R3 Inspections, LLC
P.O. Box 152205
Cape Coral, FL 33915
Office: 239.810.7793
Email: radjrsas@yahoo.com

Terrace II at Heritage Cove Association
14111 Brant Point Circle, Fort Myers, FL 33919
01-12-2012

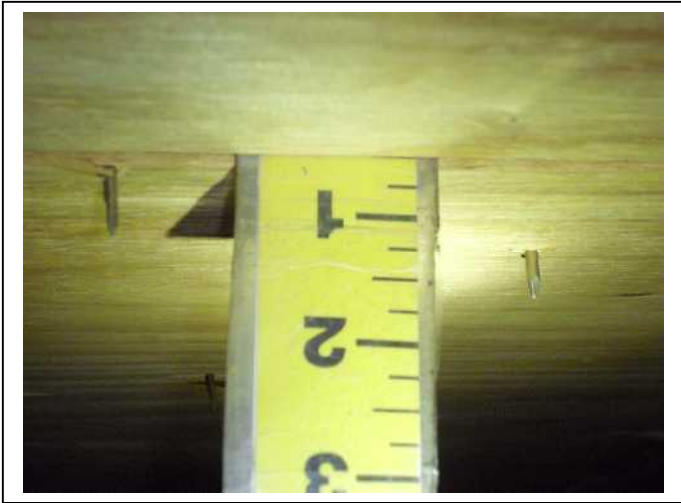
ROOF DECK THICKNESS – ½ inch plywood

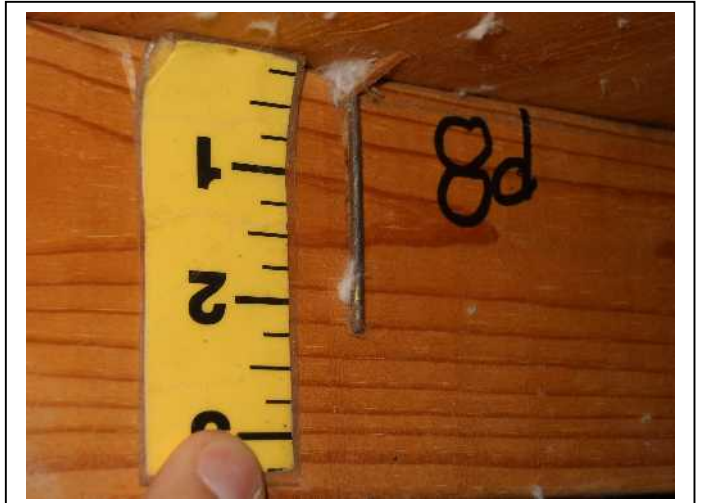
ROOF DECK ATTACHMENT – 8d nail

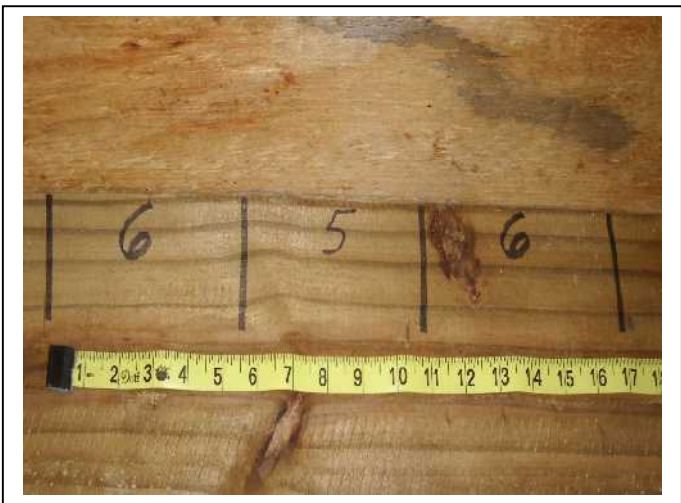
ROOF DECK ATTACHMENT – 8d@6"6"

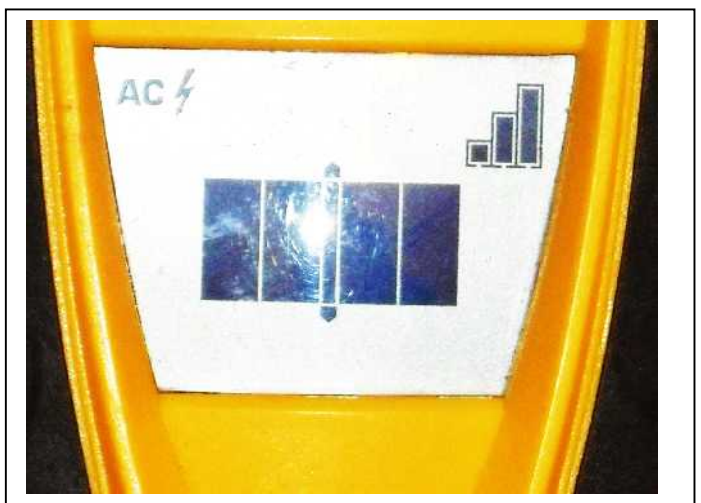
REINFORCED MASONRY EXTERIOR WALL
CONSTRUCTION

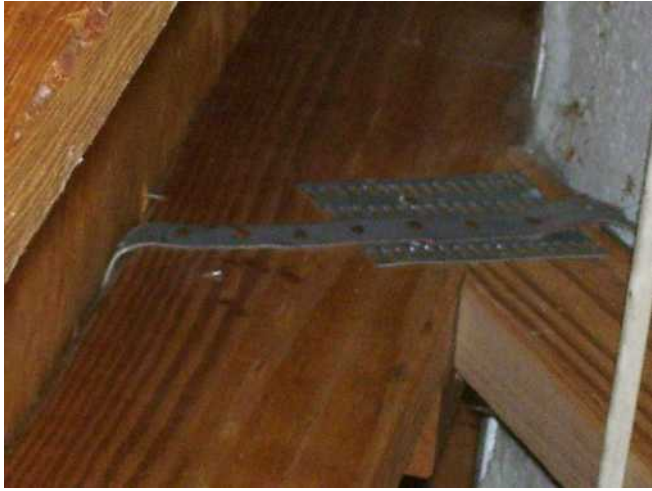
ROOF TO WALL ATTACHMENT – Properly installed Single Wraps

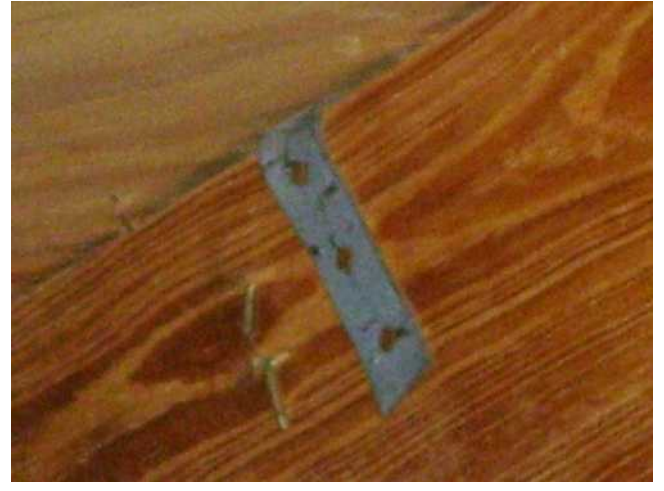
ROOF TO WALL ATTACHMENT – Properly installed Single Wraps

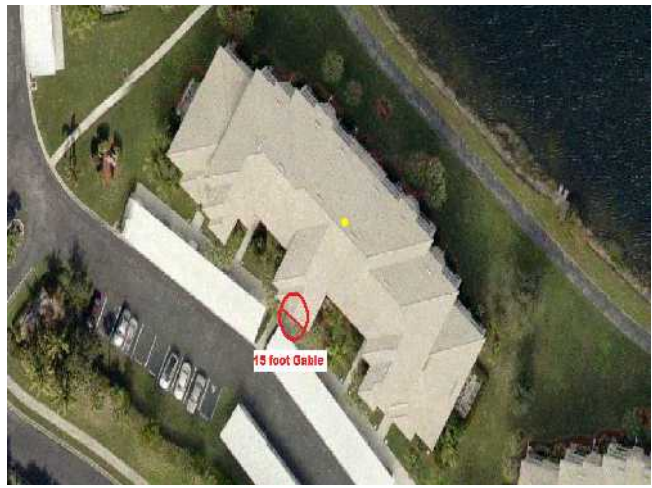
ROOF SHAPE – The length of the small gable measured 15 feet. The total roof perimeter measured 630 feet. $15 \text{ divided by } 630 = 2.38\%$.
Hip Roof Geometry

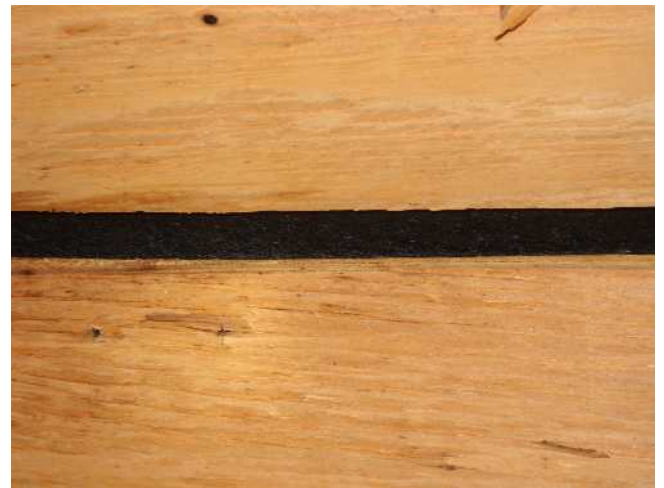
SECONDARY WATER BARRIER – Is not installed.

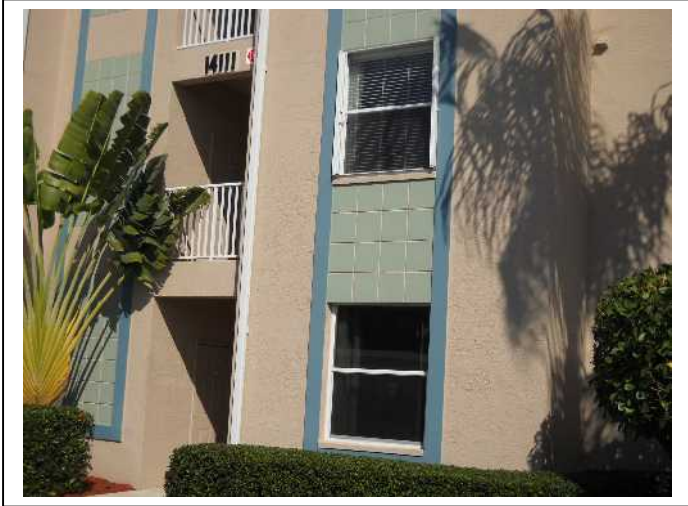
OPENING PROTECTION – Although some of the unit owners have installed wind-borne debris protection devices, others have not, leaving numerous openings (window units, hinged entry doors & sliding glass doors) unprotected.
