**R3 Inspections, LLC**  
**P.O. Box 152205**  
**Cape Coral, FL 33915**  
**Office: 239.810.7793**  
**Email: radjrsas@yahoo.com**

**Terrace IV at Heritage Cove Association**  
**14091 Brant Point Circle, Fort Myers, FL 33919**  
**01-12-2012**

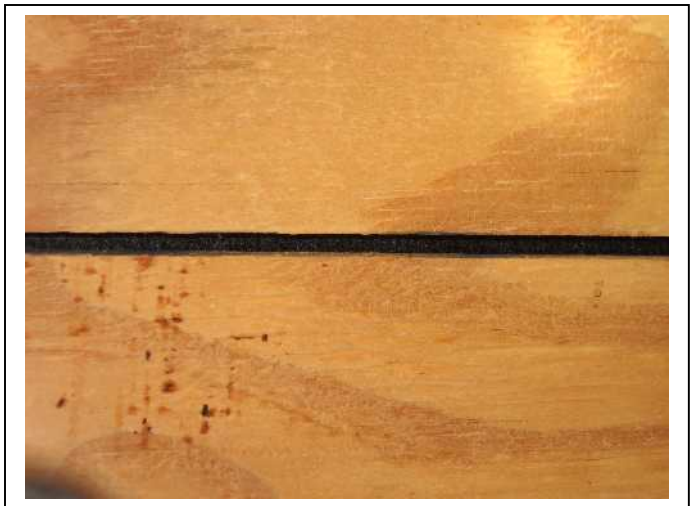
SECONDARY WATER BARRIER – Is not present.

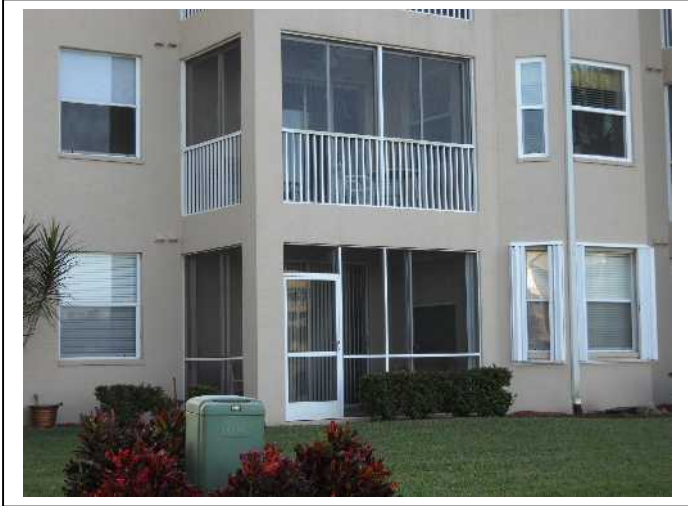
**OPENING PROTECTION – Some of the glazed openings lack wind-borne debris protection.**
