# Uniform Mitigation Verification Inspection Form

| Inspection Date: <b>05-24-2017</b> | | |
| Owner Name: <b>Terrace V at Heritage Cove Association</b> | | Contact Person: Board Member or Owner |
| Address: <b>14081 Brant Point Circle</b> | | Home Phone: |

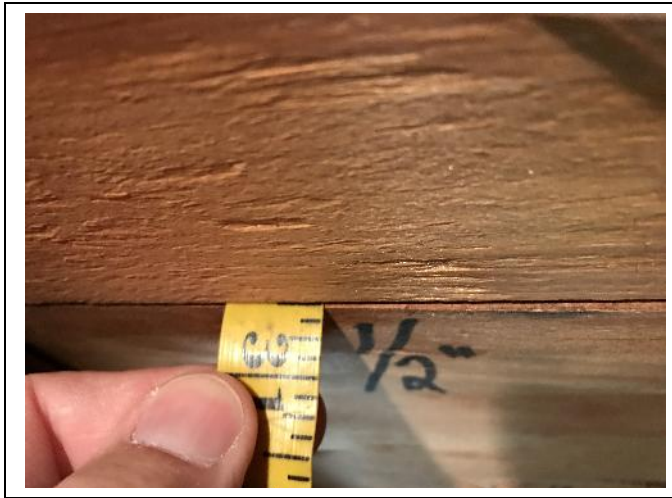
ROOF DECK THICKNESS – ½ inch plywood

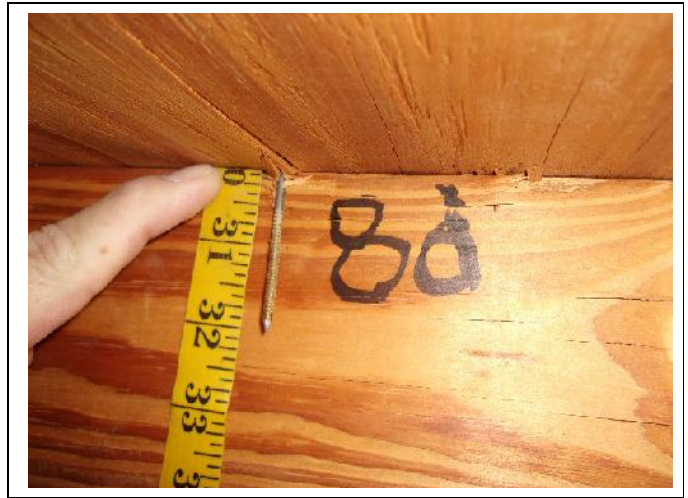
ROOF DECK ATTACHMENT – 8d ring shank nails  
added in 2017

- Remove existing tile roof system to base.
- Re-nail decking to code using #8D ring shank nails. Found on Insurance Wind Mitigation Report
- Replace any rotted 1/2" decking which we encounter during the replacement at an additional cost of \$2.00 per Sq. Ft.

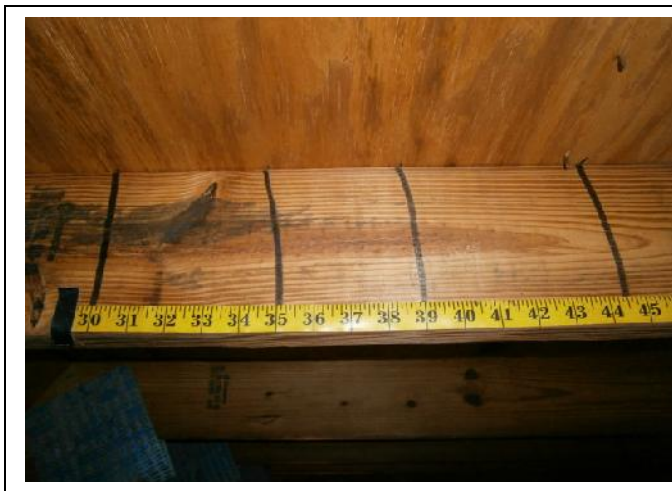
ROOF DECK ATTACHMENT – 8d nails within 6 inches  
along the edge

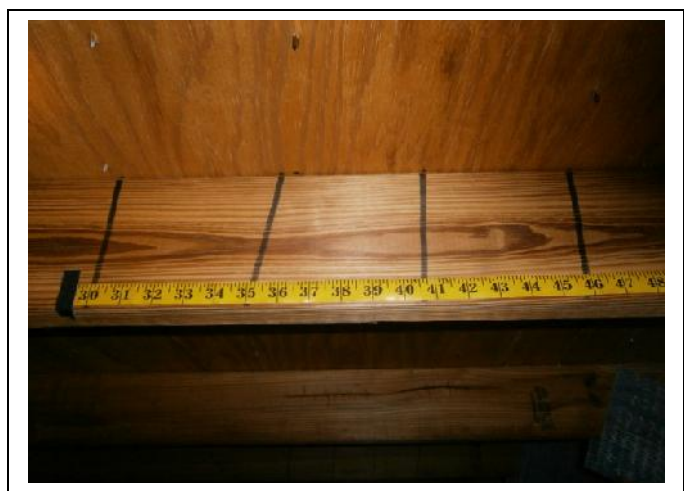
ROOF DECK ATTACHMENT – 8d nails within 6 inches  
in the field

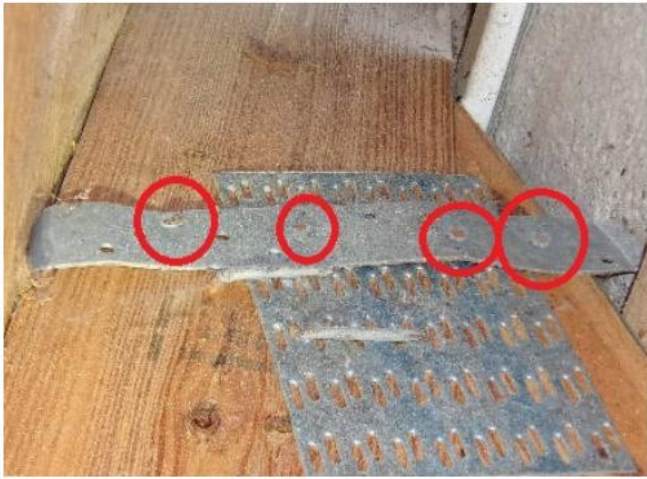
ROOF TO WALL ATTACHMENT – Properly installed  
Single Wraps

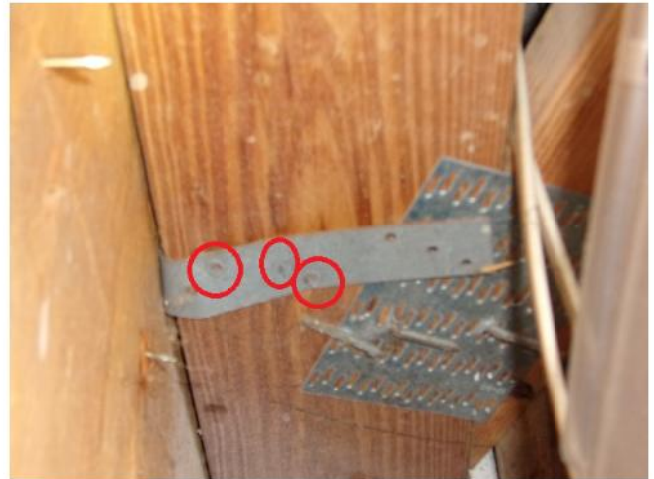
ROOF TO WALL ATTACHMENT – Properly installed  
Single Wraps

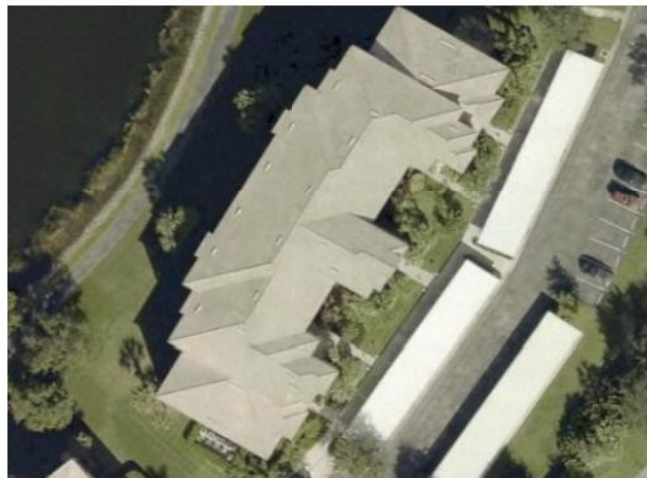
ROOF GEOMETRY Aerial View of the Ilip Roof Shape

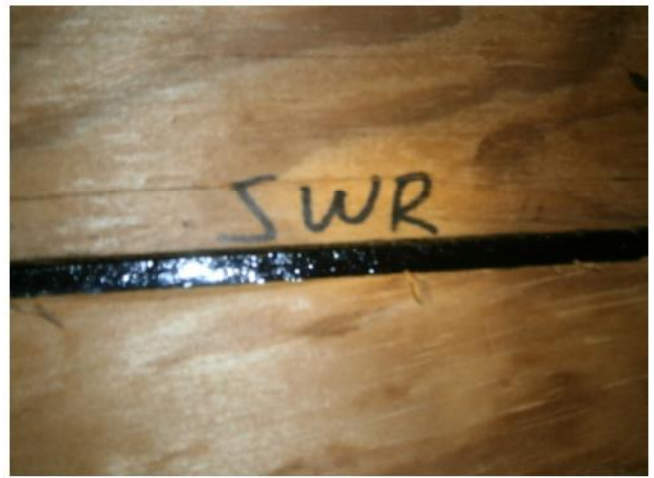
SECONDARY WATER RESISTANCE A polymer  
adhesive "peel & stick" SWR Barrier was installed on the  
entire roof deck in 2017

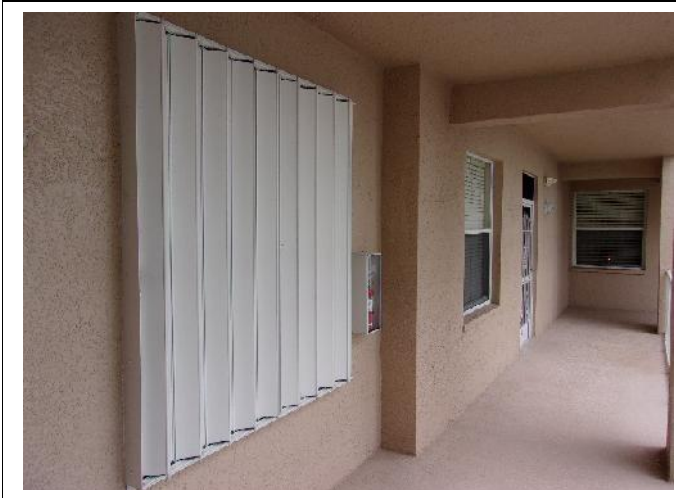
OPENING PROTECTION – Although some unit owners have installed wind-borne debris protection devices, others have not, leaving some of the openings (entry doors, window units & sliding doors) unprotected.

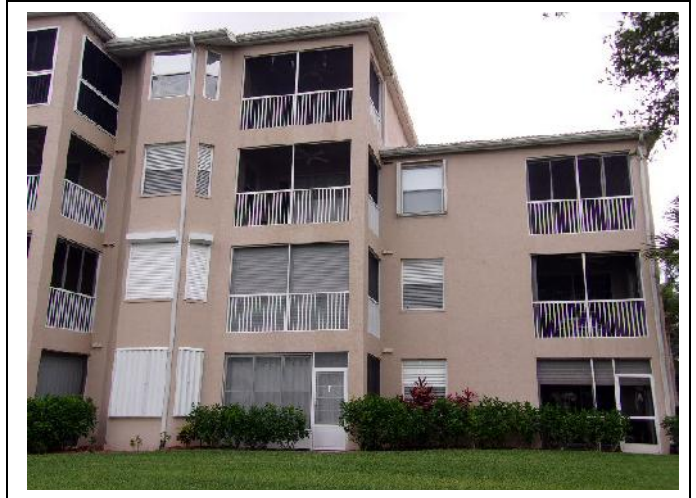
OPENING PROTECTION – Although some unit owners have installed wind-borne debris protection devices, others have not, leaving some of the openings (entry doors, window units & sliding doors) unprotected.

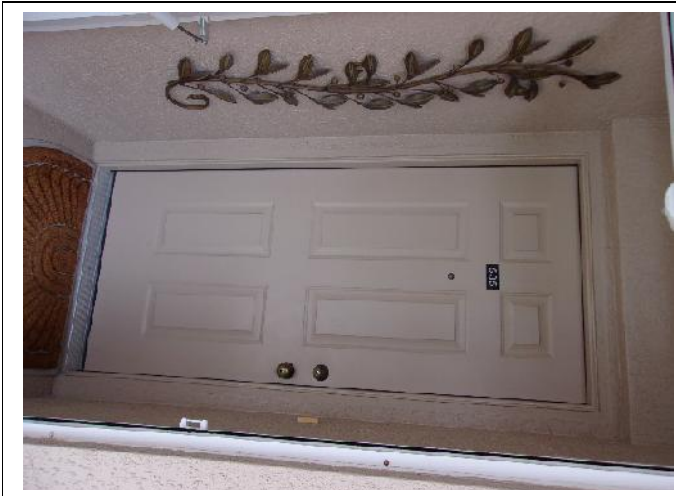
OPENING PROTECTION – Although some unit owners have installed wind-borne debris protection devices, others have not, leaving some of the openings (entry doors, window units & sliding doors) unprotected.
