# Uniform Mitigation Verification Inspection Form

| Inspection Date: <b>08-04-2020</b> | | |
| Owner Name: <b>Villas II at Heritage Cove Condominium Association</b> | | Contact Person: |
| Address: <b>14282, 14288, 14294 &amp; 14300 Prim Point Lane</b> | | Home Phone: |

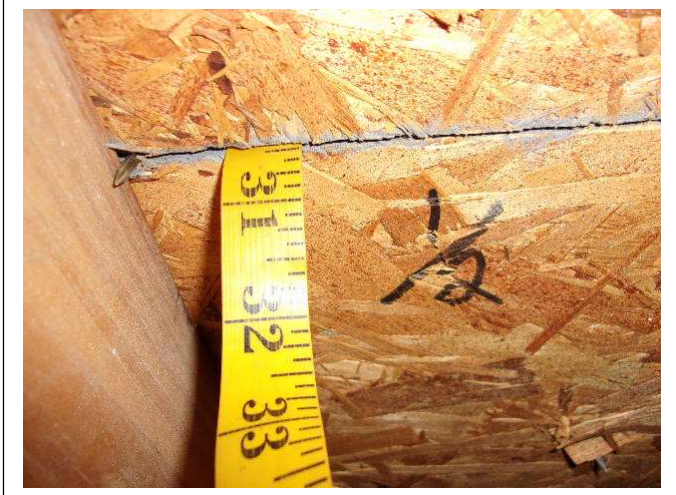
ROOF DECK THICKNESS – ½ inch OSB

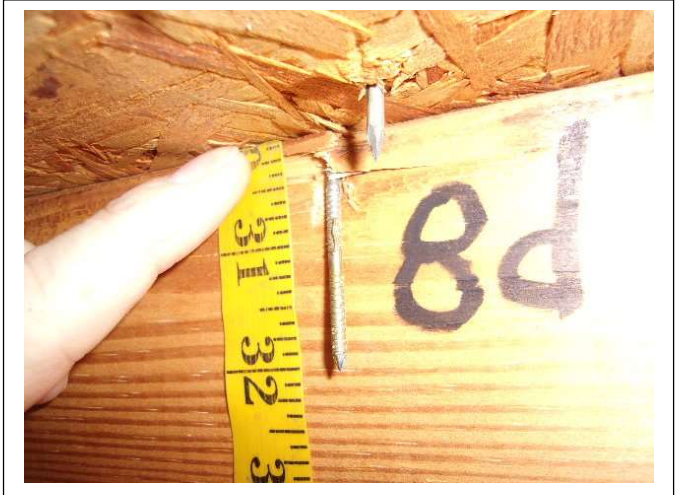
ROOF DECK ATTACHEMNT – 8d ring shank nails  
installed in 2018

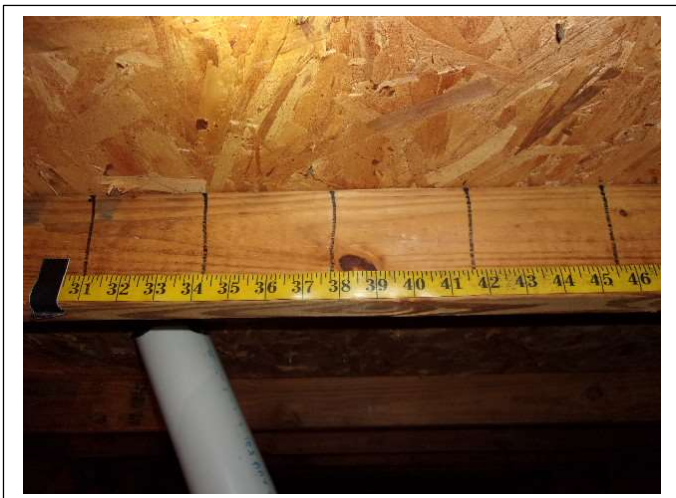
ROOF DECK ATTACHMENT – 8d nails within 6 inches  
along the edge

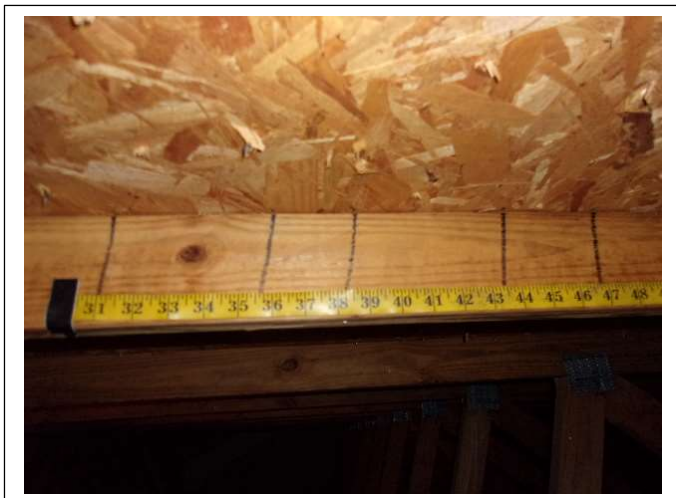
- ☒ C. Plywood/OSB roof sheathing with a minimum thickness of 7/16" inch attached to the roof truss/rafter (spaced a maximum of 24" inches o.c.) by 8d common nails spaced a maximum of 6" inches in the field. -OR- Dimensional lumber/Tongue & Groove decking with a minimum of 2 nails per board (or 1 nail per board if each board is equal to or less than 6 inches in width). -OR- Any system of screws, nails, adhesives, other deck fastening system or truss/rafter spacing that is shown to have an equivalent

ROOF DECK ATTACHMENT – 8d nails within 6 inches in  
the field

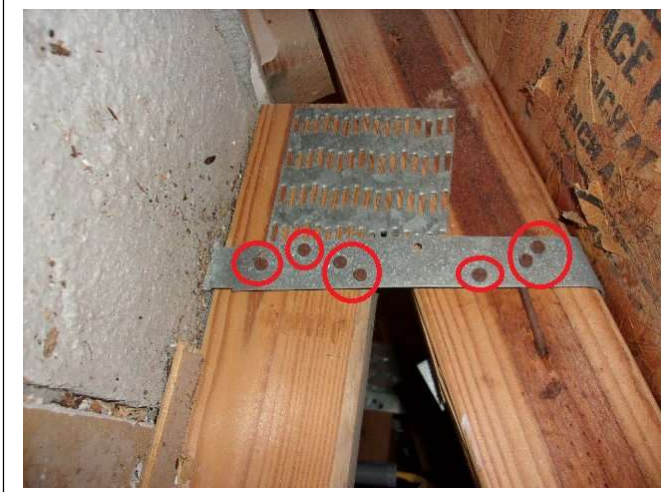
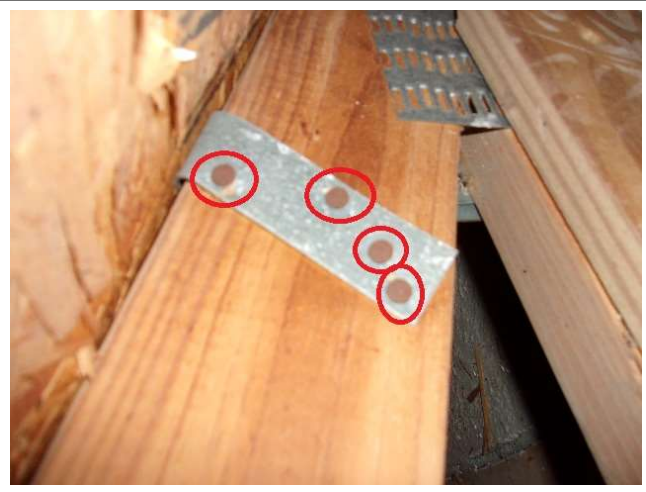
- ☒ C. Single Wraps
  - Metal connectors consisting of a single strap that wraps over the top of the truss/rafter and is secured with a minimum of 2 nails on the front side and a minimum of 1 nail on the opposing side.

ROOF TO WALL ATTACHMENT – Properly installed  
Single Wraps

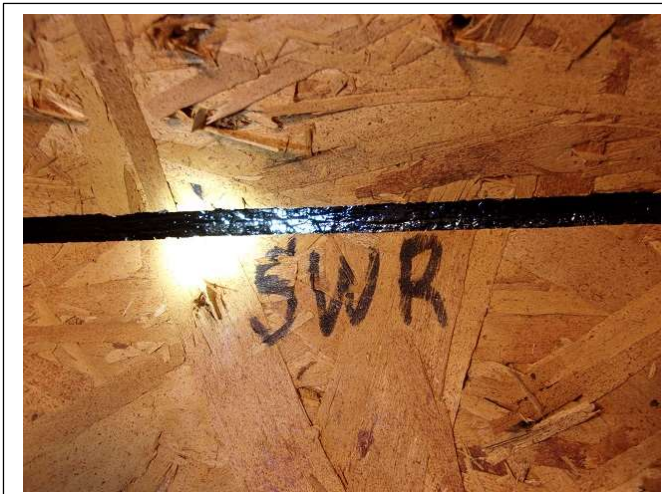
- ☒ A. SWR (also called Sealed Roof Deck) Self-adhering polymer modified-bitumen roofing underlayment applied directly to the sheathing or foam adhesive SWR barrier (not foamed-on insulation) applied as a supplemental means to protect the dwelling from water intrusion in the event of roof covering loss.
- ☐ B. No SWR.
- ☐ C. Unknown or undetermined.

SECONDARY WATER BARRIER – A polymer adhesive  
(peel & stick) SWR Barrier was installed on the entire roof  
deck in 2018

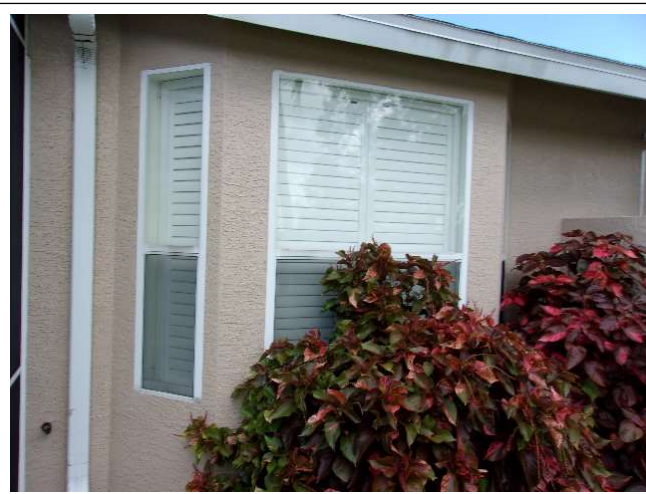
| Opening Protection Level Chart<br>Place an "X" in each row to identify all forms of protection in use for each opening type. Check only one answer below (A thru X), based on the weakest form of protection (lowest row) for any of the Glazed openings and indicate the weakest form of protection (lowest row) for Non-Glazed openings. | | Glazed Openings | | | | Non-Glazed Openings | |
|---|---|---|---|---|---|---|---|
| X | No Windborne Debris Protection | X | | | | X | X |

OPENING PROTECTION – Although some unit owners  
have installed wind-borne debris protection devices, others  
have not, leaving some openings (entry doors, window units  
and/or sliding doors) unprotected
